AM335x Sitara™ Processors Silicon Revisions 2.1, 2.0, 1.0

Silicon Errata

Literature Number: SPRZ360I
October 2011–Revised January 2017

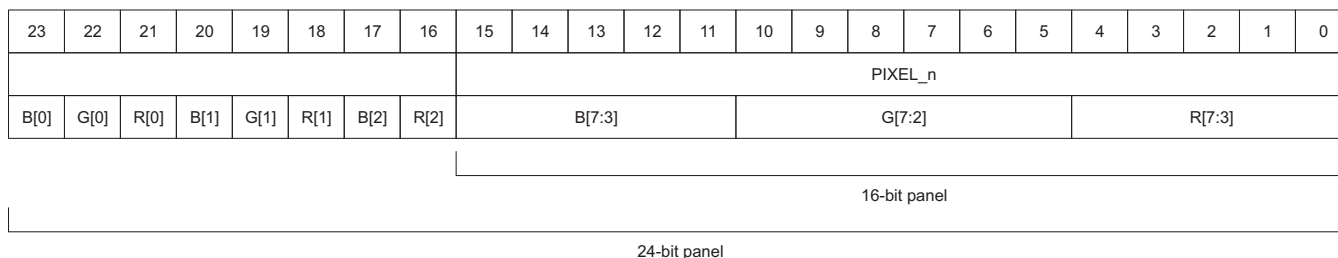
Figure 2. RGB888 Mode LCD Controller Output Pin Mapping (LCD_DATA[23:0])

The blue and red color assignments to the LCD data pins are reversed when operating in RGB888 (24bpp) mode compared to RGB565 (16bpp) mode. In order to correctly display RGB888 data from the SGX, or any source formatted as RGB in memory, it is necessary to connect the LCD panel as shown in [Figure 2](#). Using the LCD Controller with this connection scheme limits the use of RGB565 mode. Any data generated for the RGB565 mode requires the red and blue color data values be swapped in order to display the correct color.

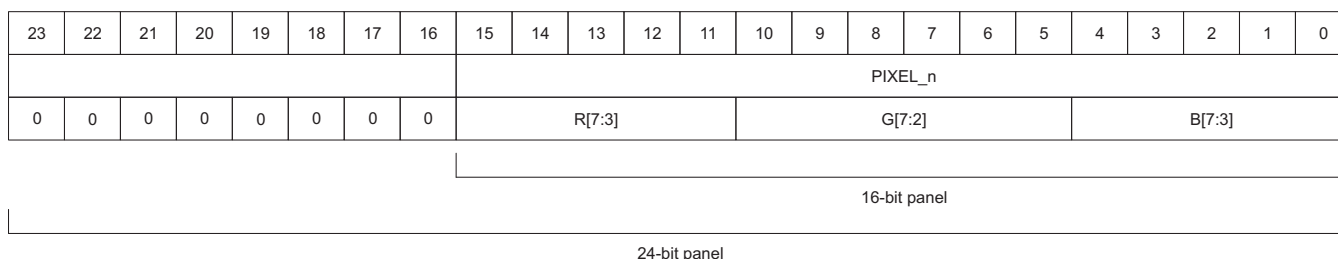
Figure 3. RGB565 Mode LCD Controller Output Pin Mapping (LCD_DATA[23:0])

When operating the LCD Controller in RGB565 mode the LCD panel should be connected as shown in [Figure 3](#). Using the LCD Controller with this connection scheme limits the use of RGB888 mode. Any data generated for the RGB888 mode requires the red and blue color data values be swapped in order to display the correct color.

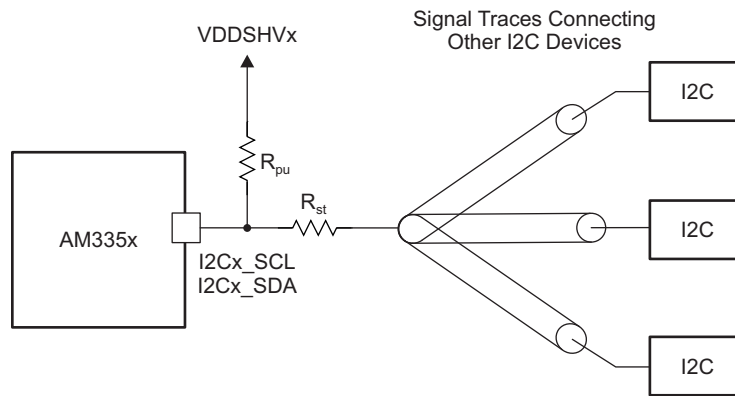
Figure 4. Placement of Series Termination Resistor and Pullup Resistor

The I2Cx_SDA and I2Cx_SCL outputs are implemented with push-pull 3-state output buffers rather than open-drain output buffers as required by I2C. While it is possible for the push-pull 3-state output buffers to behave as open-drain outputs, an internal timing skew issue causes the outputs to drive a logic-high for a duration of (0–5 ns) before the outputs are disabled. The unexpected high-level pulse will only occur when the SCL or SDA outputs transition from a driven low state to a high-impedance state and there is sufficient internal timing skew on the respective I2C output.

This short high-level pulse injects energy in the I2C signals traces, which causes the I2C signals to sustain a period of ringing as a result of multiple transmission line reflections. This ringing should not cause an issue on the SDA signal because it only occurs at times when SDA is expected to be changing logic levels and the ringing will have time to damp before data is latched by the receiving device. The ringing may have enough amplitude to cross the SCL input buffer switching threshold several times during the first few nanoseconds of this ringing period, which may cause clock glitches. This ringing should not cause a problem if the amplitude is damped within the first 50 ns because I2C devices are required to filter their SCL inputs to remove clock glitches. Therefore, it is important to design the PCB signal traces to limit the duration of the ringing to less than 50 ns. One possible solution is to insert series termination resistors near the AM335x SCL and SDA terminals to attenuate transmission line reflections.

This issue may also cause the SDA output to be in contention with the slave SDA output for the duration of the unexpected high-level pulse when the slave begins its ACK cycle. This occurs because the slave may already be driving SDA low before the unexpected high-level pulse occurs. The glitch that occurs on SDA as a result of this short period of contention does not cause any I2C protocol issue but the peak current applies unwanted stress to both I2C devices and potentially increases power supply noise. Therefore, a series termination resistor located near the respective AM335x SDA terminal is required to limit the current during the short period of contention.

A similar contention problem can occur on SCL when connected to I2C slave devices that support clock stretching. This occurs because the slave is driving SCL low before the unexpected high-level pulse occurs. The glitch that occurs on SCL as a result of this short period of contention does not cause any I2C protocol issue because I2C devices are required to apply a glitch filter to their SCL inputs. However, the peak current applies unwanted stress to both I2C devices and potentially increases power supply noise. Therefore, a series termination resistor located near the respective AM335x SCL terminal is required to limit the current during the short period of contention.

Insert series termination resistors on the SCL and SDA signals and locate them near the AM335x SCL and SDA terminals. The SCL and SDA pullup resistors should also be located near the AM335x SCL and SDA terminals. The placement of the series termination resistor and pullup resistor should be connected as shown in [Figure 4](#).

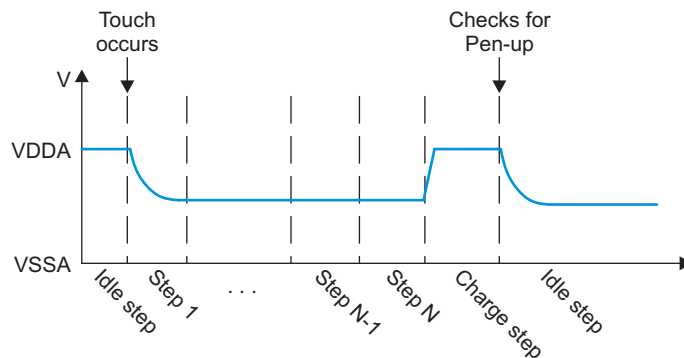
Figure 5. TSC Generates False Pen-up Interrupt

Details The touchscreen controller (TSC) determines the pen state (up or down) by checking the respective analog input (AIN0 for 4-wire or AIN4 for 5-wire) voltage level immediately after the Charge step. This does not provide enough time for the analog input voltage to return to the normal Pen-down voltage before testing the pen state. This will cause the TSC to generate a false Pen-up interrupt if the Charge step is enabled with the strong pull-up turned on when using hardware synchronized steps. [Figure 5](#) illustrates the effect on the analog voltage when constant pen pressure is applied to the touchscreen and held through the Charge step.
